Land Information Memorandum

L241140

Valuation No.	2405514300
Location	153 Lincoln Rolleston Road
Legal Description	LOT 2 DP 568976
Owner	Yoursection FV Limited
Area (hectares)	10.6750

Soil Contamination Risk
Detailed Site Investigation Report
and Remediation Action Plan

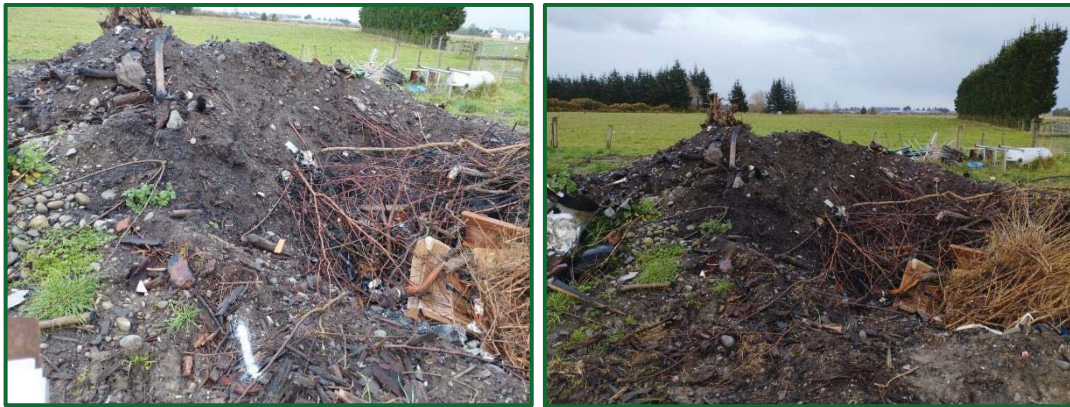
The owner stated that the pit in the north-eastern corner of the yard area was the only rubbish pit used at the site. This is inconsistent with information obtained from the site inspection completed as part of the PSI, however excavations in the area where an additional pit was thought to be did not identify any fill or rubbish material. The existing pit contained blackened, ashy material which appeared to be burnt rubbish and a tree stump, red brick, some building rubble, general household rubbish and organics. Surface soils directly surrounding the pit were also dark and appeared to have been impacted by the burning of rubbish, however underlying soils appeared visually clean and unaffected by the rubbish pit and burning of material. Soil samples were collected from the stockpiled material surrounding the pit and from the pit itself.

Photo 1 & 2 – Existing rubbish pit (sample location TP1)

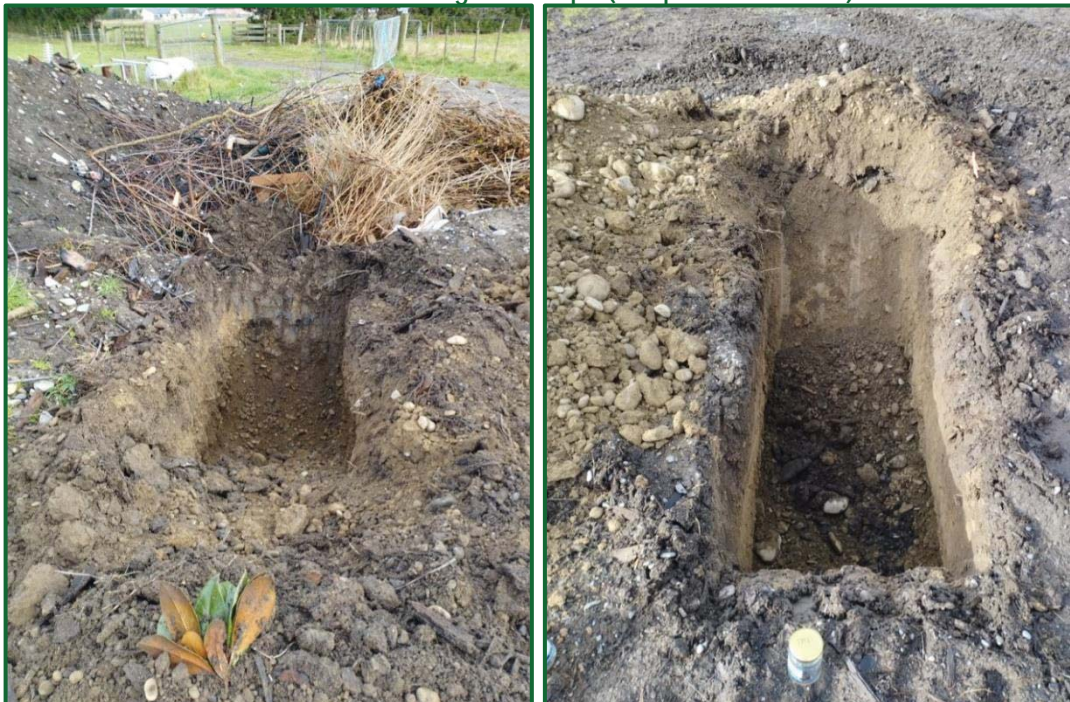
Photo 3 & 4 – Test pit within existing rubbish pit (sample location TP1)

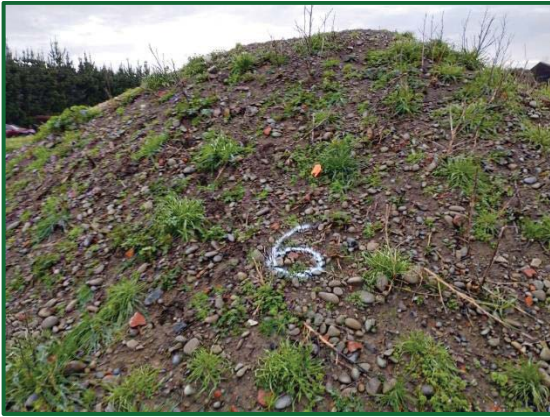
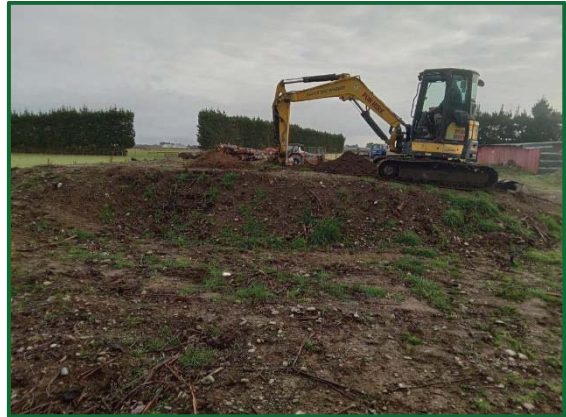
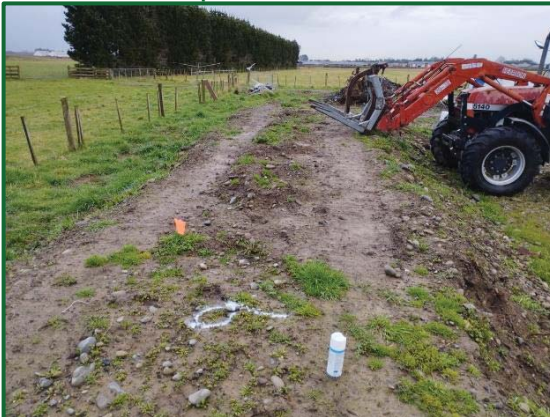
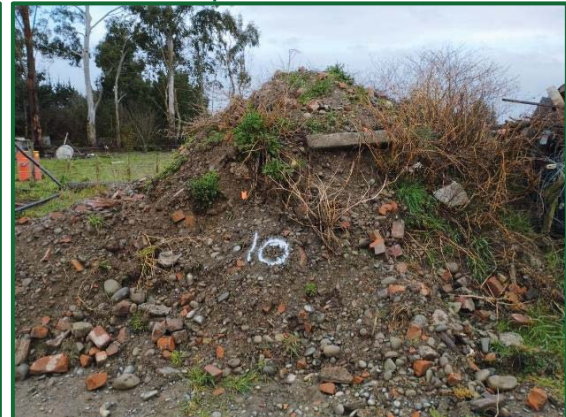
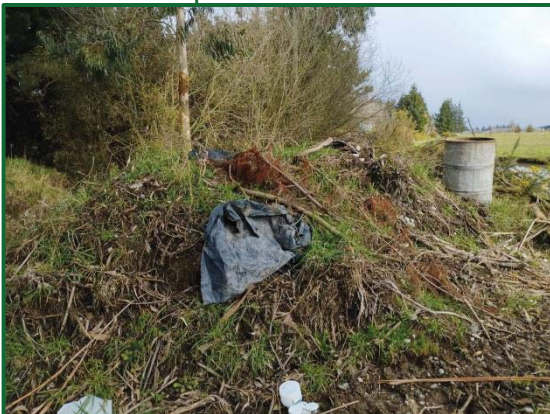
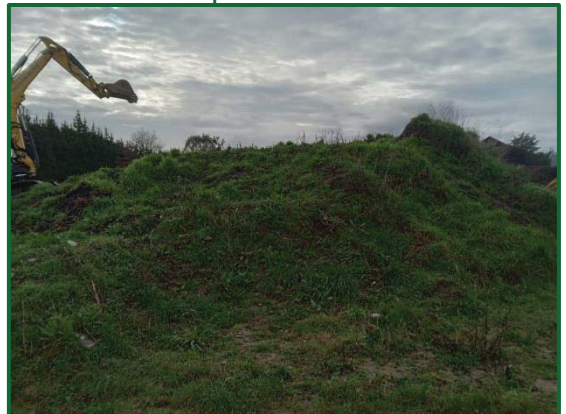
Samples collected from test pit locations TP6, TP7, TP9, TP11 and TP17 represented soils from large stockpiles. The owner stated that no soils had been brought onto site. A large amount of bricks had been brought onto the site and had been stockpiled in test pit location 6 and test pit location 10, as shown in the photos below. The remaining stockpiles of material were generally topsoils and gravels excavated from different areas of the site intended to be used for levelling or filling lower areas of the yard. The samples collected from the stockpiles were in-field composite samples. This was considered an appropriate sampling technique as each stockpile originated from the same source and allowed for good representation of the stockpile as a whole.

Photo 5 – Test pit location 6

Photo 6 – Test pit location 7

Photo 7 – Test pit location 9

Photo 8 – Test pit location 10

Photo 9 – Test pit location 11

Photo 10 – Test pit location 17

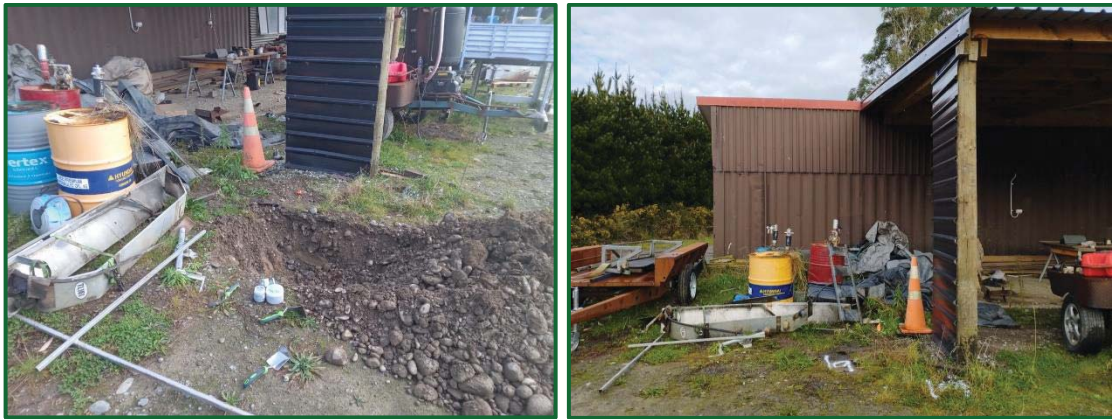
Samples collected from test pit location TP19 represent soils adjacent to the smoko/office room and an area used for machinery storage. Soils from this location were stained and appeared to have been impacted by adjacent oil/fuel storage. Samples collected from test pit location TP20

Photo 11 & 12 – Test pit location 19

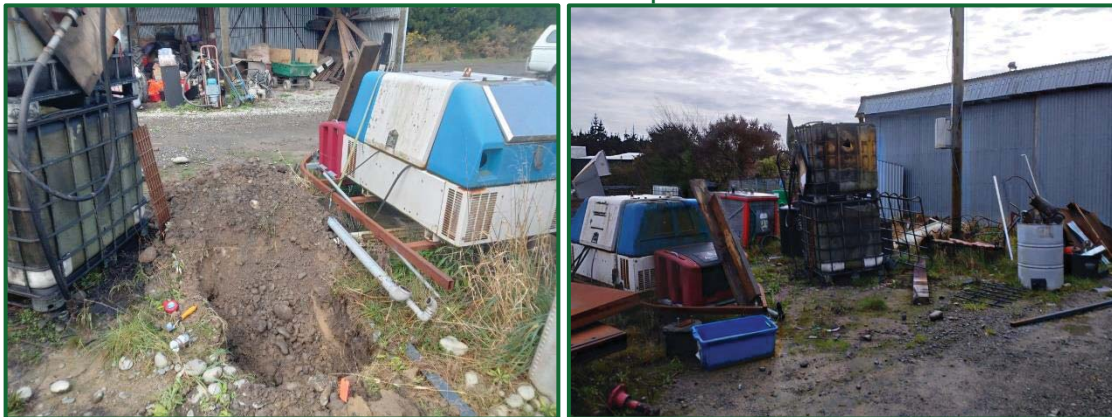
Photo 13 & 14 – Test pit location 20

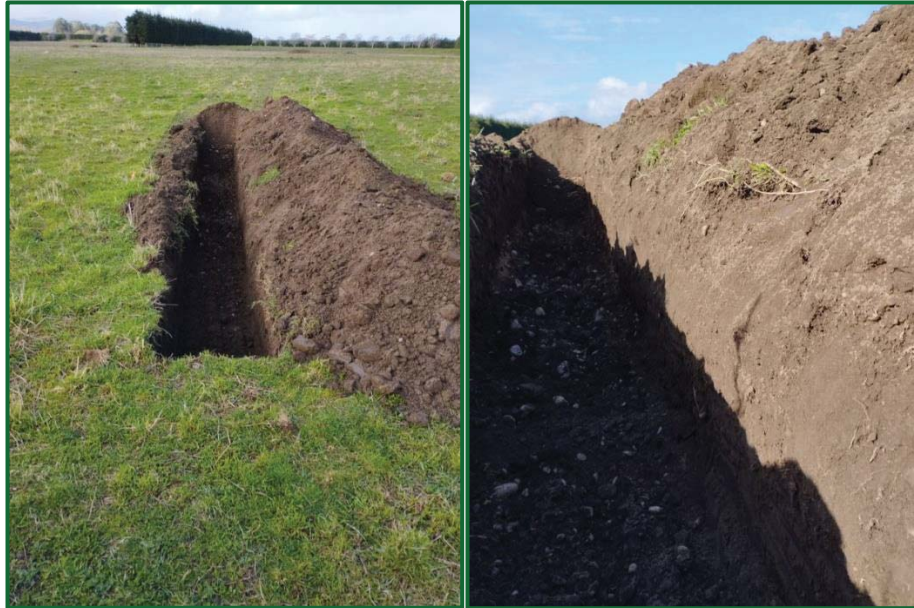
The owner of the site stated that the two areas of disturbance/introduced fill in the north-western paddock were locations where the owner had excavated pits to access the gravel and backfilled with topsoils from other areas of the site and potting mix. Two trenches were excavated in locations advised by the owner, which were consistent with the historical aerial images as areas of soil disturbance. There was no evidence of refuse material or any other anthropogenic material in either trench. The soils from both trenches consisted of brown topsoils with some sand and rounded gravels. Soil samples were collected from both of the trenches at depths of 0-100mm and 400mm.

Photo 15 & 16 – Test pit location 24

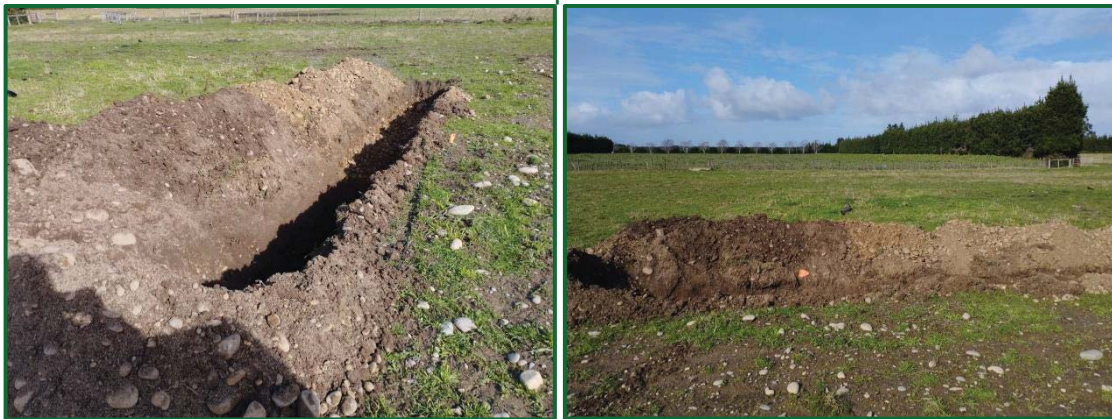
Photo 17 & 18 – Test pit location 25

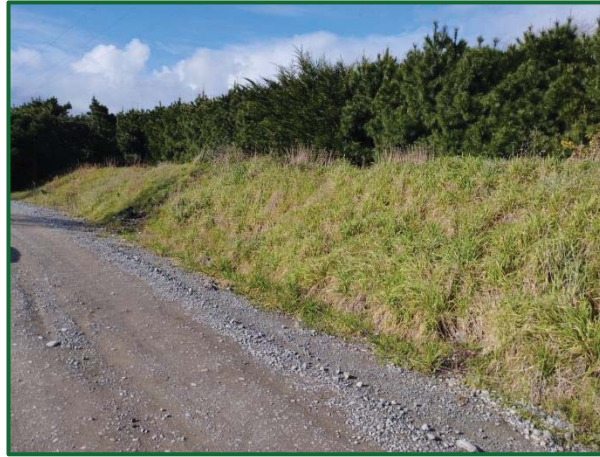
The owner also advised of a large stockpile of soil located along the entrance to the site. The soils were sourced from the yard area, which were stripped before the yard was gravelled. In-field composite samples were also collected from this stockpile. The soils in this stockpile consisted of brown topsoils with some sand and rounded gravels. In-field composite samples were also collected from this stockpile. This was considered an appropriate sampling technique as each stockpile originated from the same source and allowed for good representation of the stockpile as a whole.

Photo 19 – Test pit location 27

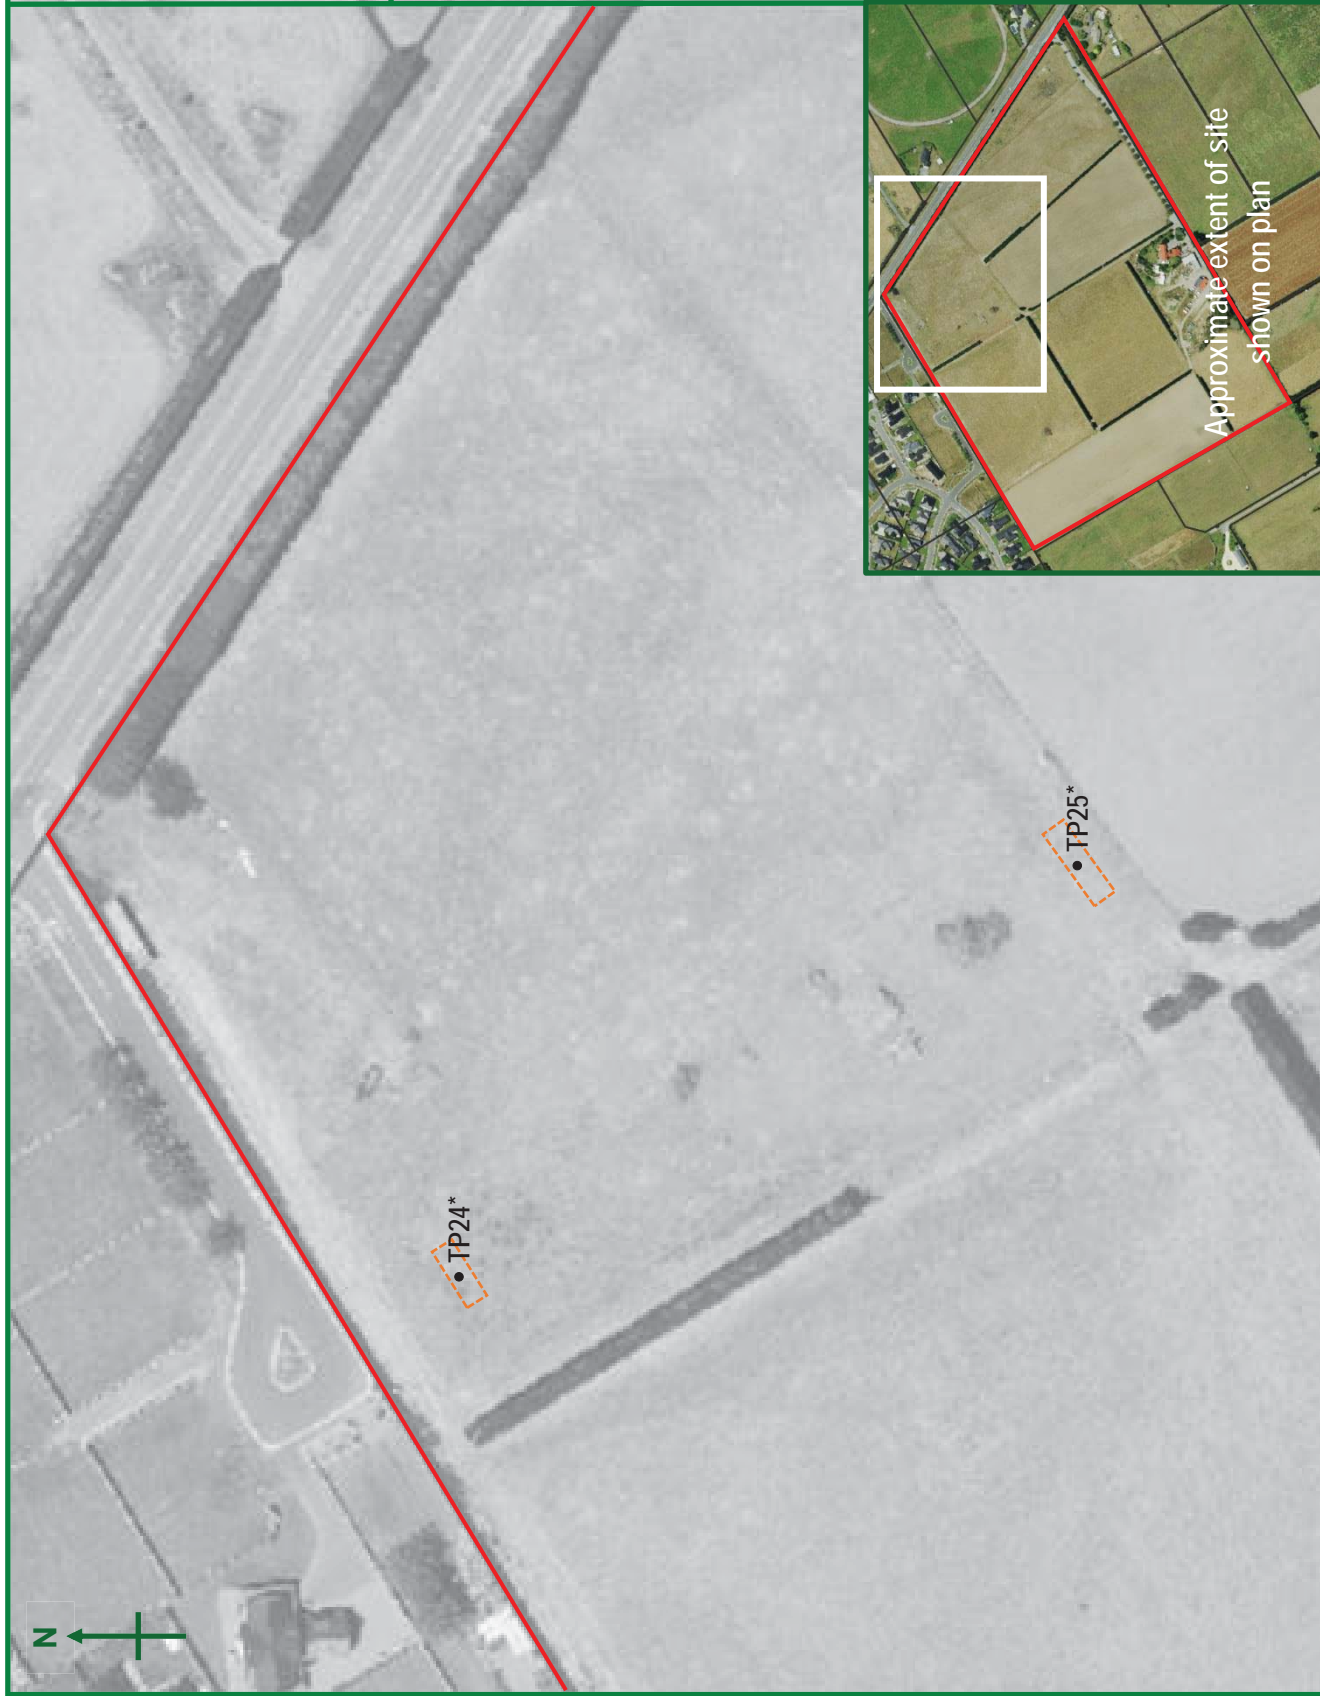
Sample Location Plan (Disturbed/Introduced Fill Area)

- 1 This plan has been prepared for soil contamination risk assessment purposes only. No liability is accepted if the plan is used for any other purposes.
- 2 Any measurements taken from this plan which are not dimensioned on the electronic copy are at the risk of the user.
- 3 Soil sample locations are approximate only

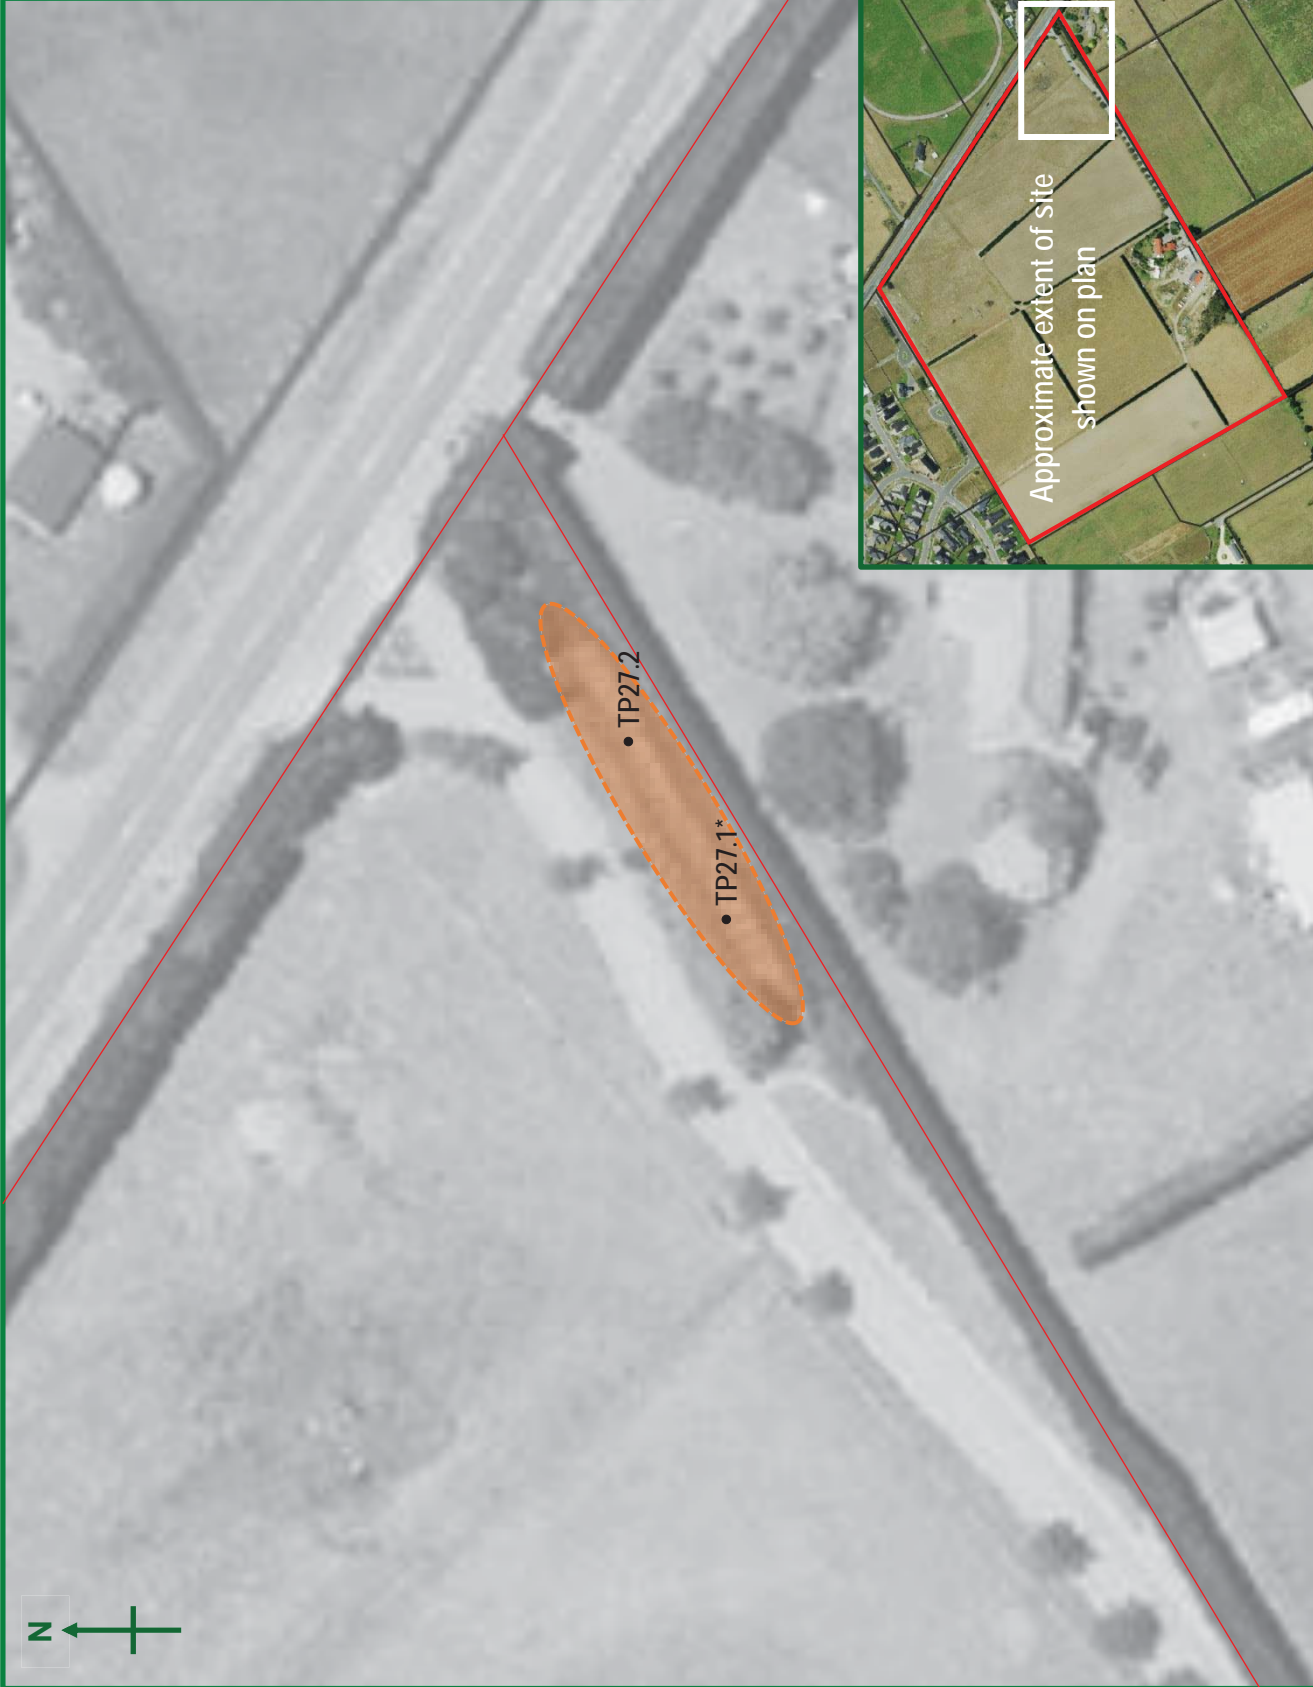
- 1 This plan has been prepared for soil contamination risk assessment purposes only. No liability is accepted if the plan is used for any other purposes.
- 2 Any measurements taken from this plan which are not dimensioned on the electronic copy are at the risk of the user.
- 3 Soil sample locations are approximate only

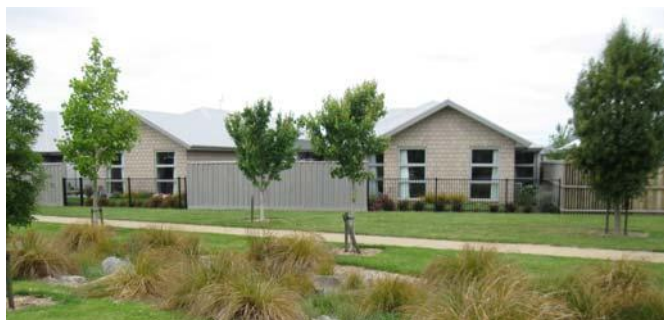
Best practice design

Use dark colours for fence to merge into landscape.

Support and soften open fence with complementary plantings.

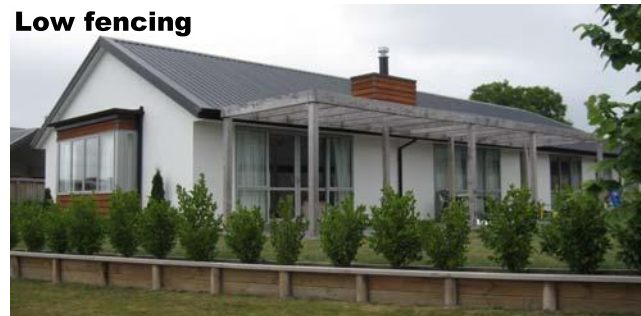
Low fencing

This type of fence consists of small or low level fencing that is supported by plantings. Hedges and gardens offer many of the same benefits as taller fences and are cost effective in comparison to enclosed tall fences. They also offer the following advantages:

- Less potential for graffiti
- Perceived extension of property
- Softer appearance to edges that adds to attractive neighbourhoods
- Complementary to the Selwyn context: leafy, green, open
- Can be individually designed to change with the seasons

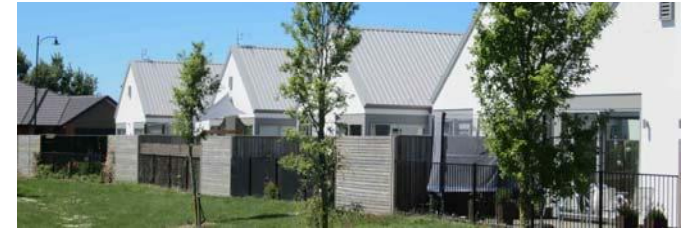
Rule 4.17 Fencing along reserve boundary

- ✓ All fencing of any allotment that shares a boundary with a public reserve or a walkway shall be limited to a single fence to be erected within 5m of that boundary and
- ✓ All fencing of any allotment that shares a boundary with a public reserve or a walkway shall be a max. of 1.2m in height and
- ✓ All fencing of any allotment that shares a boundary with a public reserve or a walkway shall be at least 50% transparent where it exceeds 1.2m in height
