Geotechnical Investigation and Assessment Report for Subdivision

511 Halswell Road, Halswell, Christchurch

Document Ref: **190666-RP-001[A]**

Prepared for: **Yoursection Ltd**

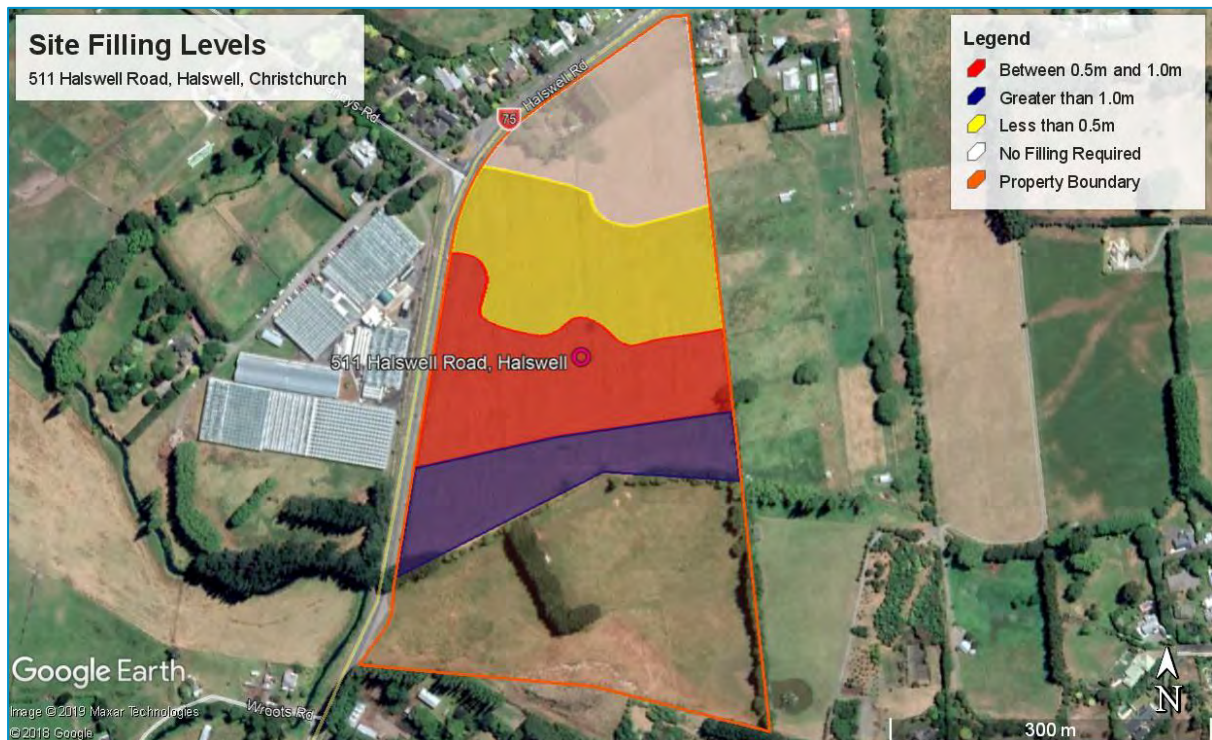
Figure 6: Approximate extents of Site Filling

The approximate extent of filling that would be required to reach the required levels is shown in Figure 6.

As discussed above, the majority of the site will require filling to meet the CCC FFL requirements (FFL = 12.25mCDD), particularly if the preferred foundation options comprise concrete slab foundations.

In order to mitigate the effects of settlement of the underlying soft soils, filling including pre-loading the land with a stockpile of material until the majority of the settlement has occurred is geotechnically feasible. It is unlikely that the entire site would require pre-loading (potentially limited to where greater than 0.5m to 1.0m filling is required over shallow soft soils) and this option could be undertaken through a staged approach whereby material utilised in the stockpile for the pre-loading phase could be utilised as engineered fill for other areas of the site.
