# Land Information Memorandum

Property address:  
511 Halswell Road

Project: MINZ200357 - Geotechnical Investigation and Assessment  
 Location: 2 & 4 Glovers Road Subdivision, Halswell, Christchurch

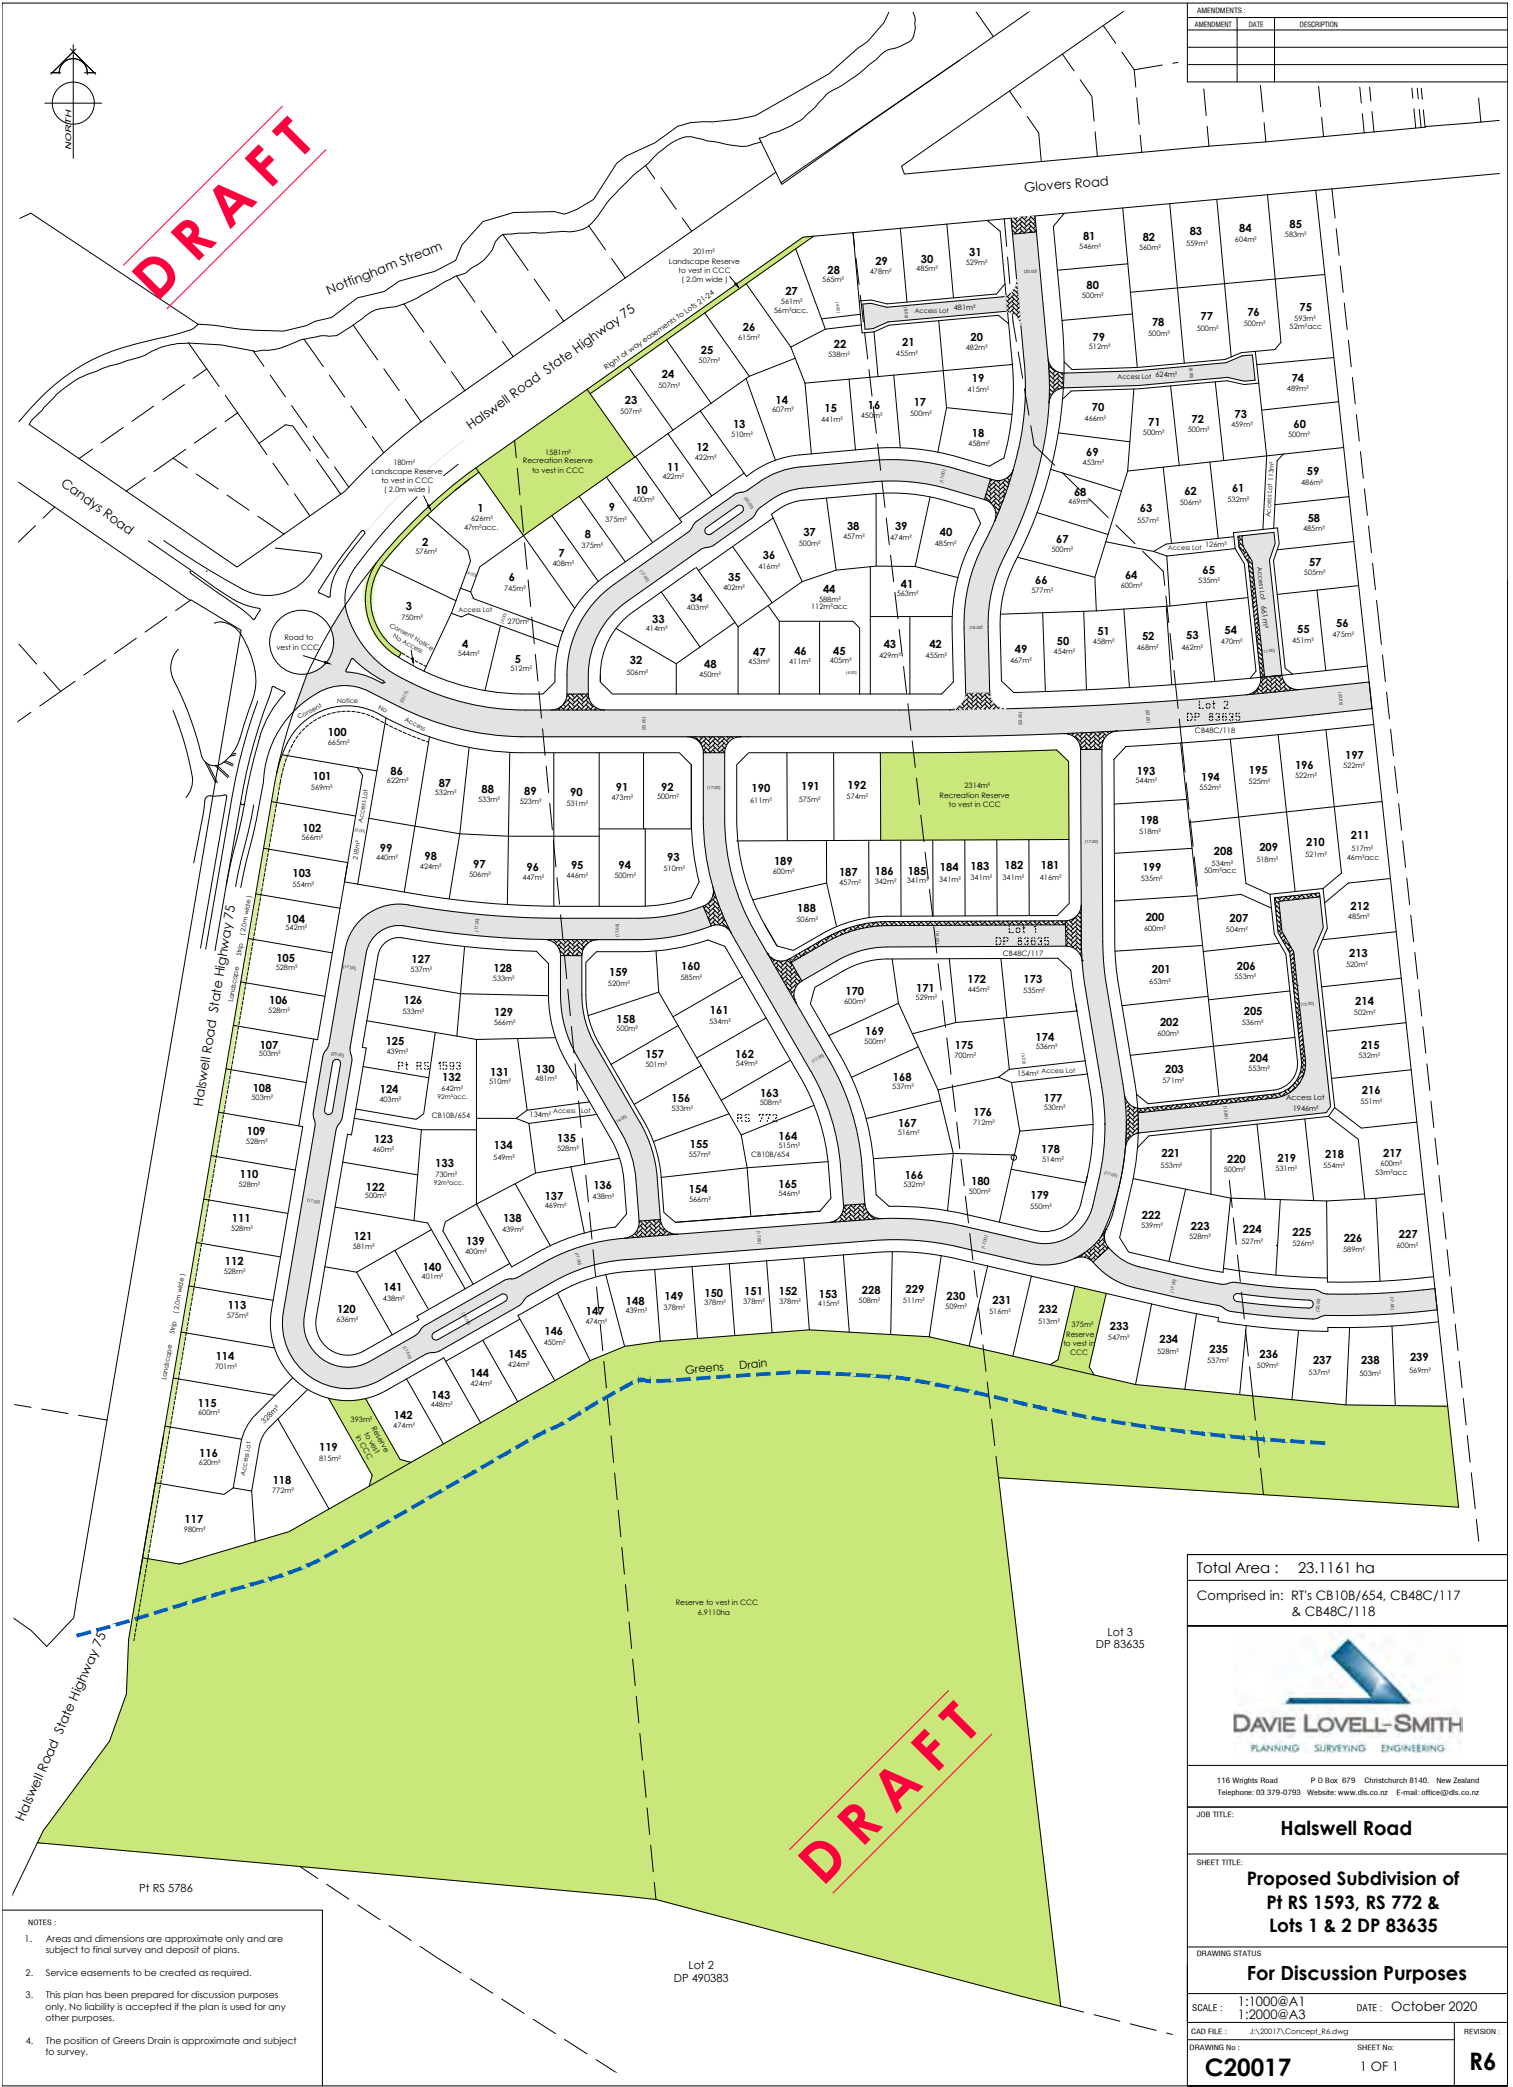
Total Area : 23.1161 ha  
 Comprised in: RT's CB108/654, CB48C/117 & CB48C/118

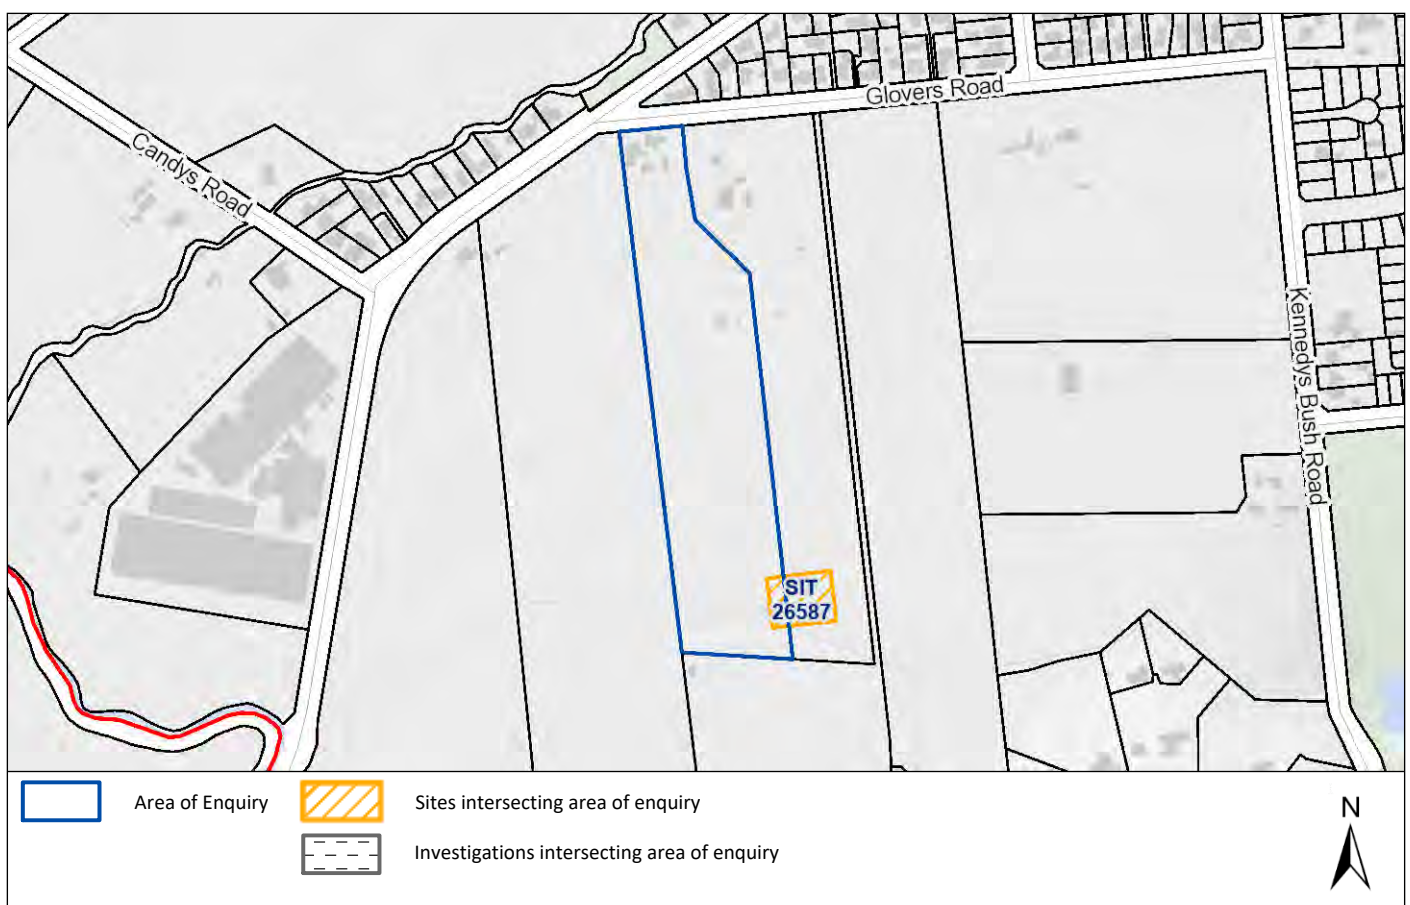
Date:	13 October 2020	
Land Parcels:	Lot 1 DP 83635	Valuation No(s): 2356209300

17 Oct 2013                      Area defined from: 1994-2004 ECan Aerial Photographs  
 Note: Multiple glass houses were noted in aerial photographs reviewed.

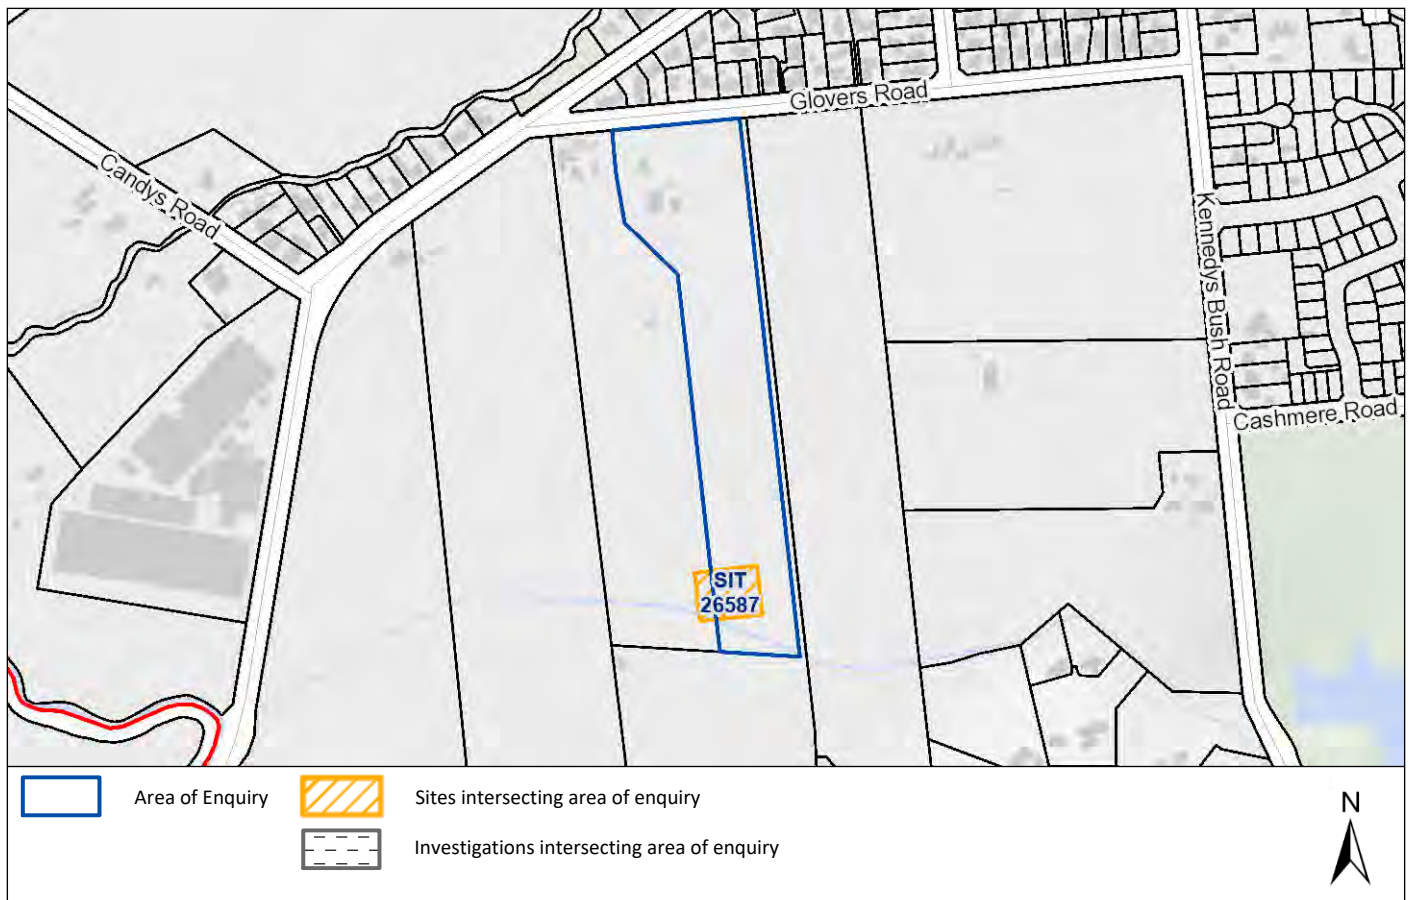
<b>Date:</b>	13 October 2020	
<b>Land Parcels:</b>	Lot 2 DP 83635	Valuation No(s): 2356209301

17 Oct 2013                    Area defined from: 1994-2004 ECan Aerial Photographs  
 Note: Multiple glass houses were noted in aerial photographs reviewed.
